**INVESTIGATING THE DIMINISHING BOREHOLE YIELDS IN MALAWI: CASE
STUDY OF NANKUMBA IN MANGOCHI DISTRICT**

**A thesis submitted to the Faculty of Applied Sciences, University of Malawi, The
Polytechnic, in partial fulfilment of the requirements for the award of the degree of
Master of Science in Water Resources and Supply Management (MSc. WRSM)**

February, 2017

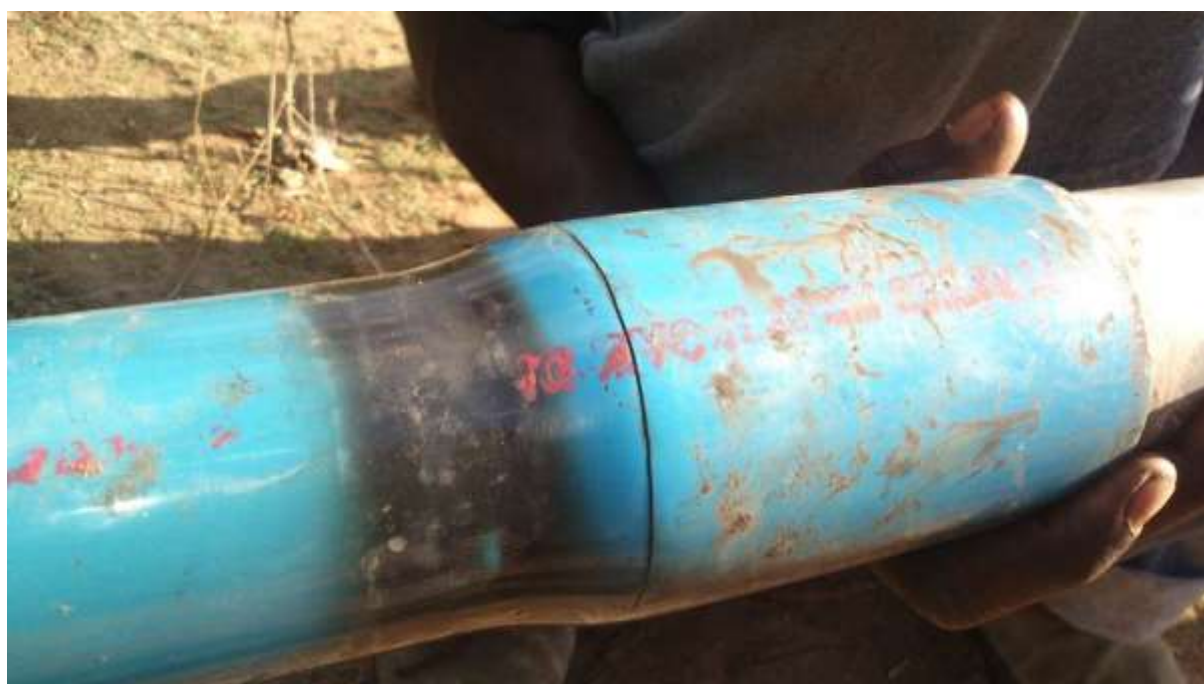
Figure 15: Cracked Rising Main

It was also revealed that all these 8 (100%) boreholes had deeper pump installation depths that ranged from 46m to 55m as can be seen in Table 4 below. The cracks, as seen in Figure 15 below were therefore caused by high stresses on the upper rising mains as a result of heaviness as argued by Lutz et al. (2014) that mechanical stresses on hand pump parts are greater for deeper pump installations.

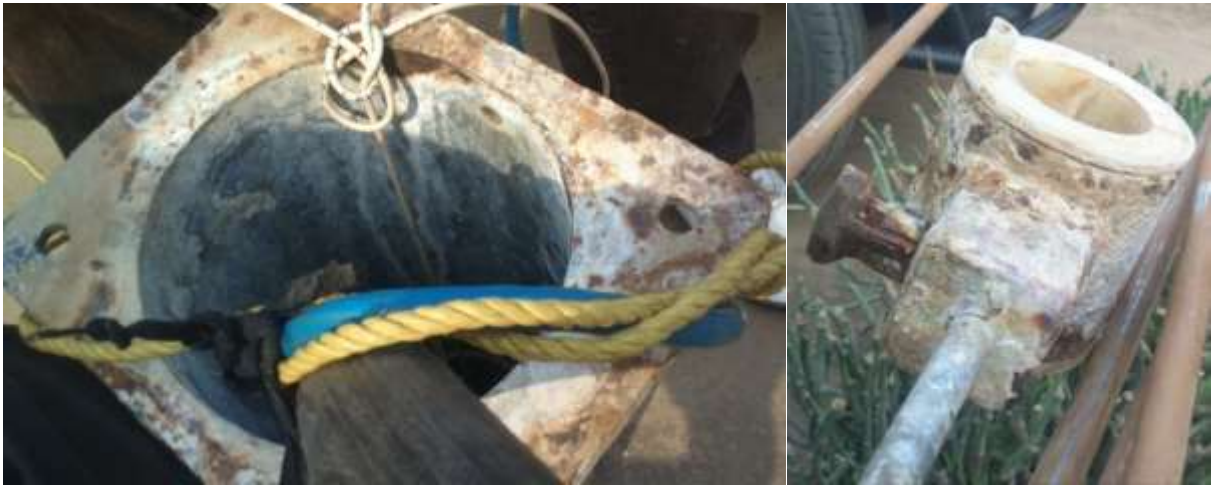
Figure 16: Severe Corrosion Due to Salty Water

One other thing that was revealed in this study through the assessment of pump parts was that there were three (3) serious cases of corrosion on metal parts of the hand pumps. This

corrosion mainly attacked parts like hunger housing, pedestal, bolts and nuts. This corrosion was solely due to salty water. Figure 16 below is a pictorial view of the severe corrosion that attacked metal parts.

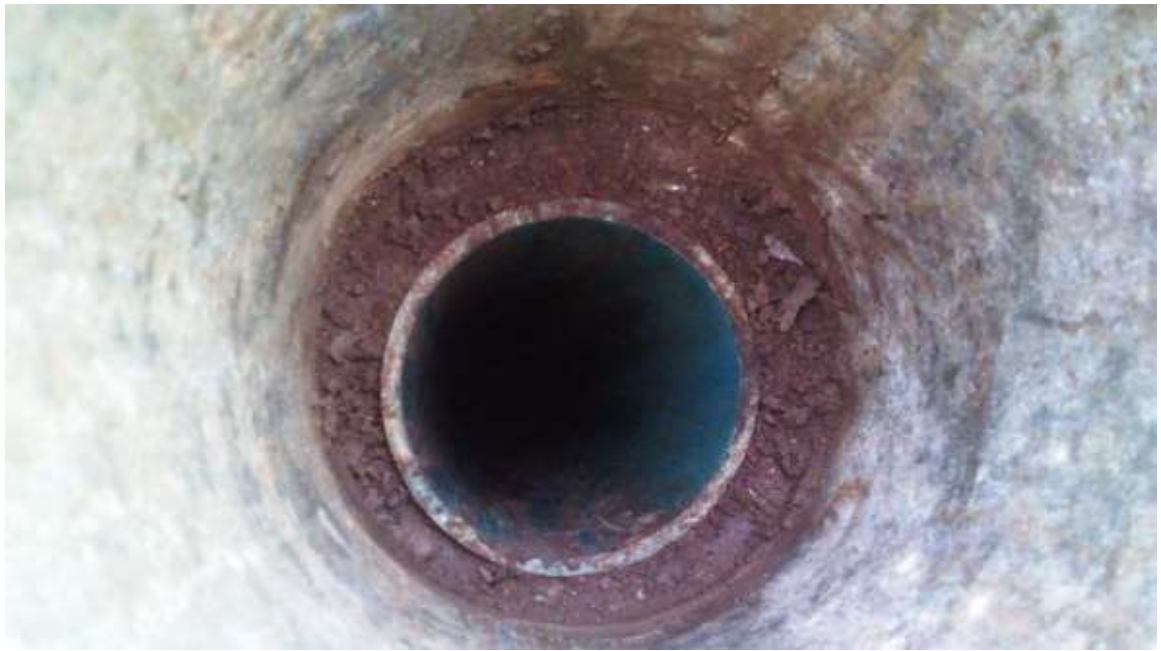
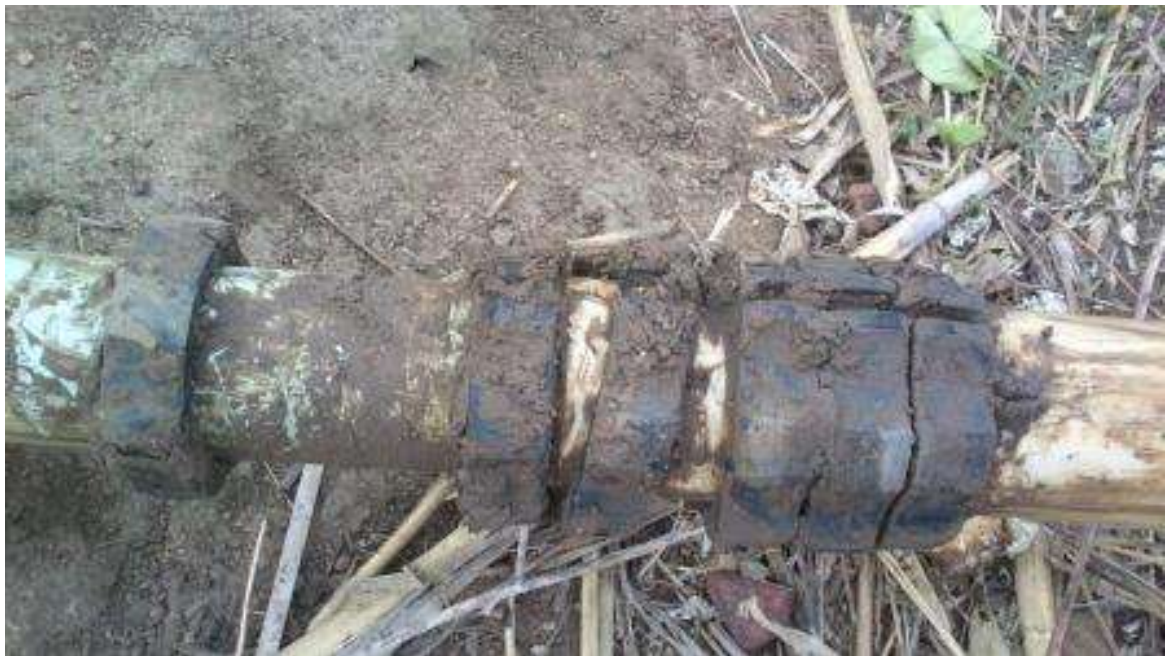
Figure 17: Termite Mound Developing in a Borehole (Top Picture) and Muddy Rising Main (Bottom Picture)

From the same assessment, 2 boreholes were found to be experiencing clogging of the slots and the foot valve. 1 borehole was found to be clogged with small roots from a nearby tree and these roots had gone through the slots, blocking the passage of inflowing water. On the other borehole, it was found that termite mound had developed between the pedestal and the casing as in Figure 17. This led to the clay falling inside the borehole and clogging the pumping system as well as the affecting the quality of water.

Although this clogging did not indicate any significant effect on the yielding of the boreholes at the time of study, in the long run it could have serious impact as the accumulation of the roots and the clay could hamper the pump operation as well as the inflow of water.
