**INVESTIGATING THE DIMINISHING BOREHOLE YIELDS IN MALAWI: CASE
STUDY OF NANKUMBA IN MANGOCHI DISTRICT**

**A thesis submitted to the Faculty of Applied Sciences, University of Malawi, The
Polytechnic, in partial fulfilment of the requirements for the award of the degree of
Master of Science in Water Resources and Supply Management (MSc. WRSM)**

February, 2017

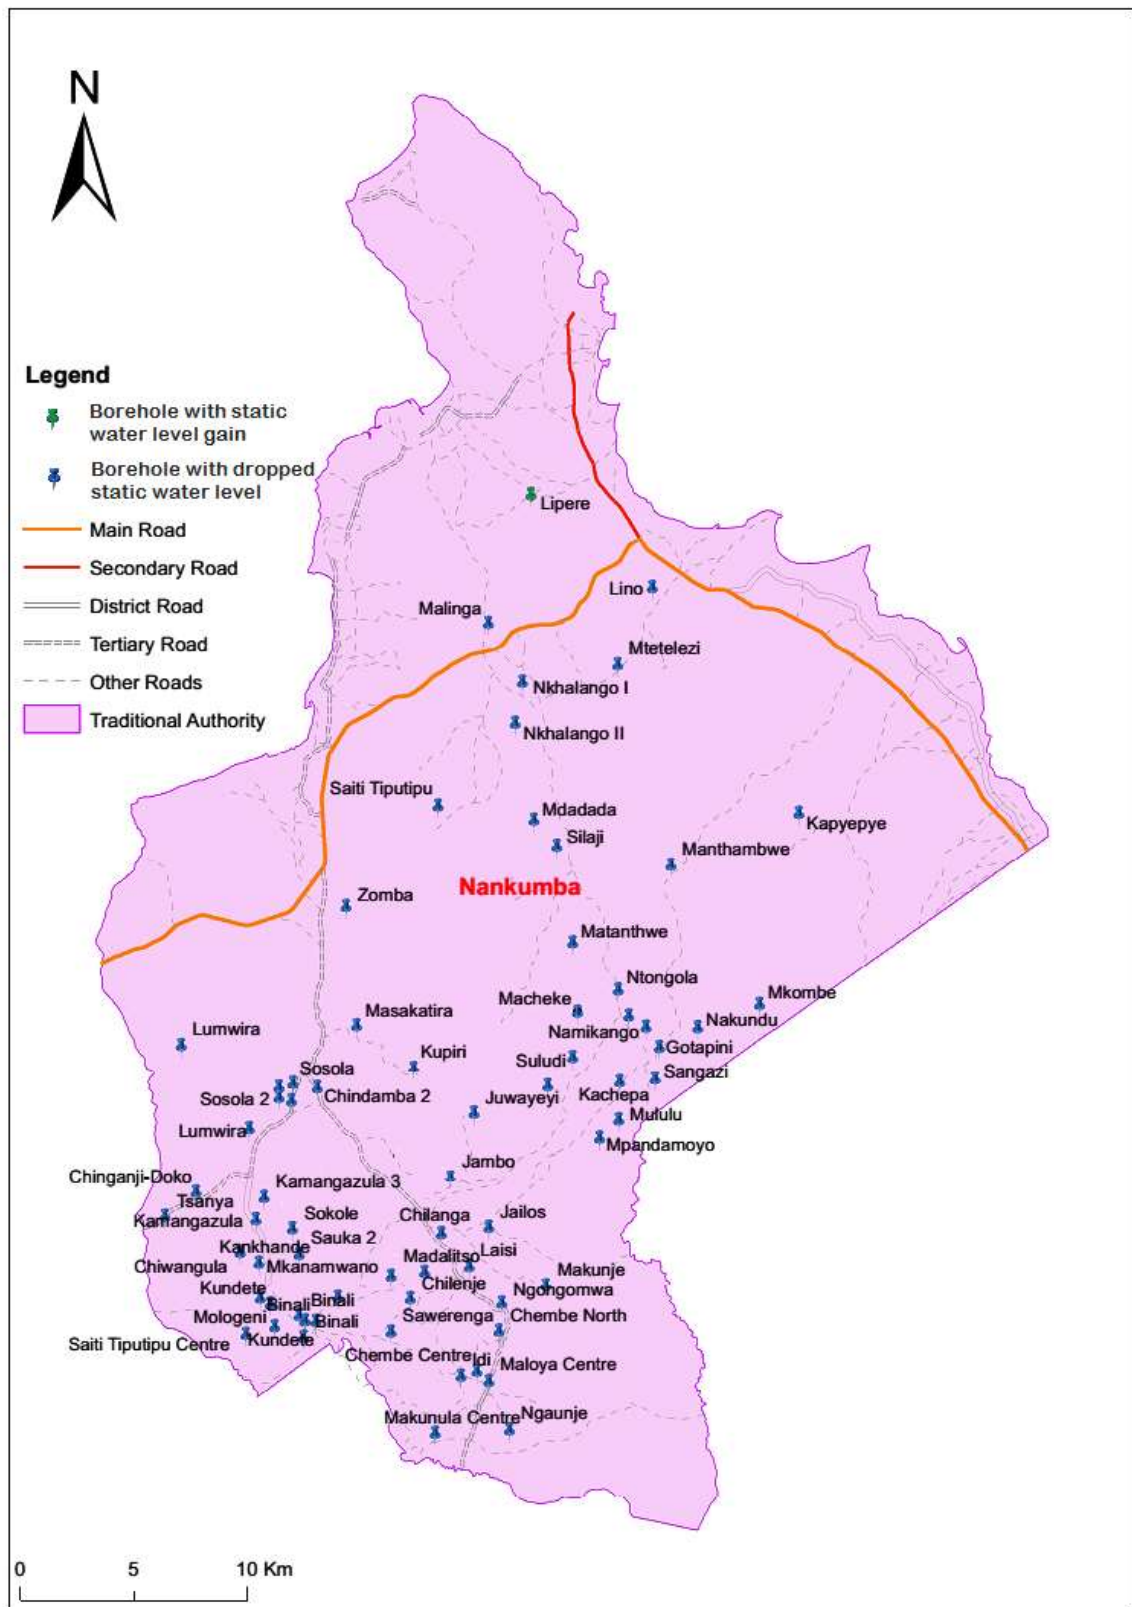
Figure 4: Map of T.A. Nankumba Showing the Localities of the Boreholes with Gain or Drop in Static Water Levels

One of the parameters that were considered during the pumping tests was static water level. It was revealed that out of the 70 boreholes tested, one borehole (1.4%) had gained⁶ in static water level by 2.53m, while 69 (98.6%) had dropped in static water level and Figure 4 below provides details of how these boreholes were localised. The dropping ranged between 0.04m as the minimum drop⁷ and 13.04m as the maximum drop. This could indicate some serious deficiencies in groundwater recharge in the study area as argued by Ayotte et al. (2010) who state that the amount of groundwater recharge affects static water levels. These changes in static water levels are as a result of changes in groundwater storage (ΔS) and can be illustrated by the groundwater balance formula below as provided by Kumar (2005) as well as Taheri Tizro, Voudouris, and Eini (2007).

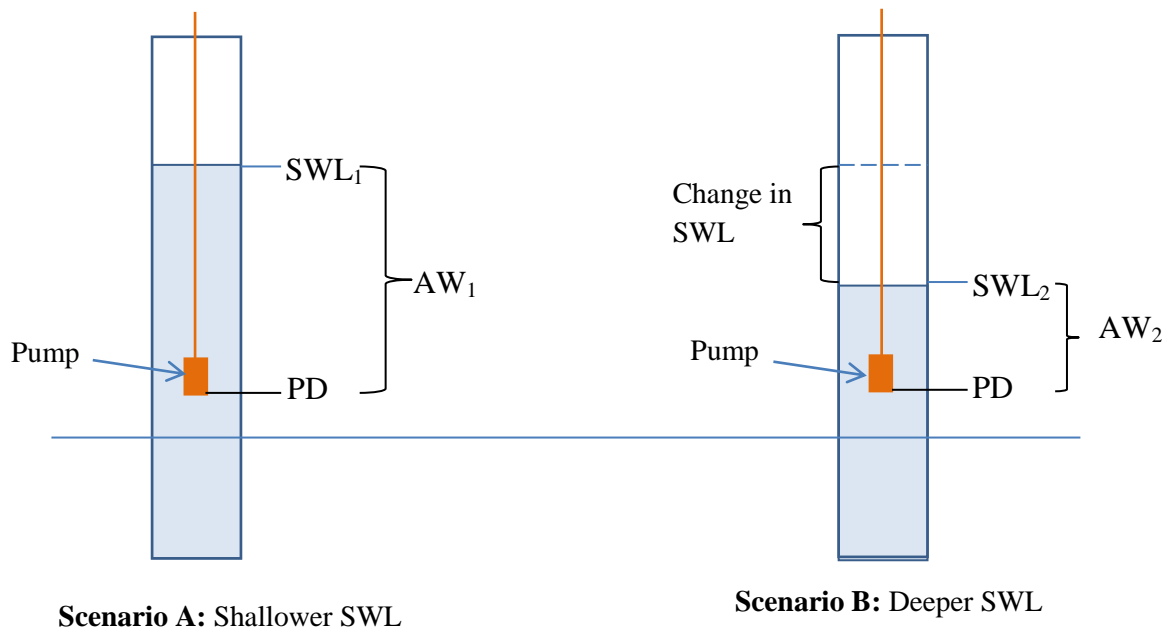
Figure 5: Illustration of Changes in Static Water Levels

It is worthy to also note that as the static water levels get deeper, the column of available water, which is the difference between pump depth (PD) and the static water level (SWL), diminishes thereby reducing the amount of water that could be drawn in a given time as illustrated in Figure 5 below.

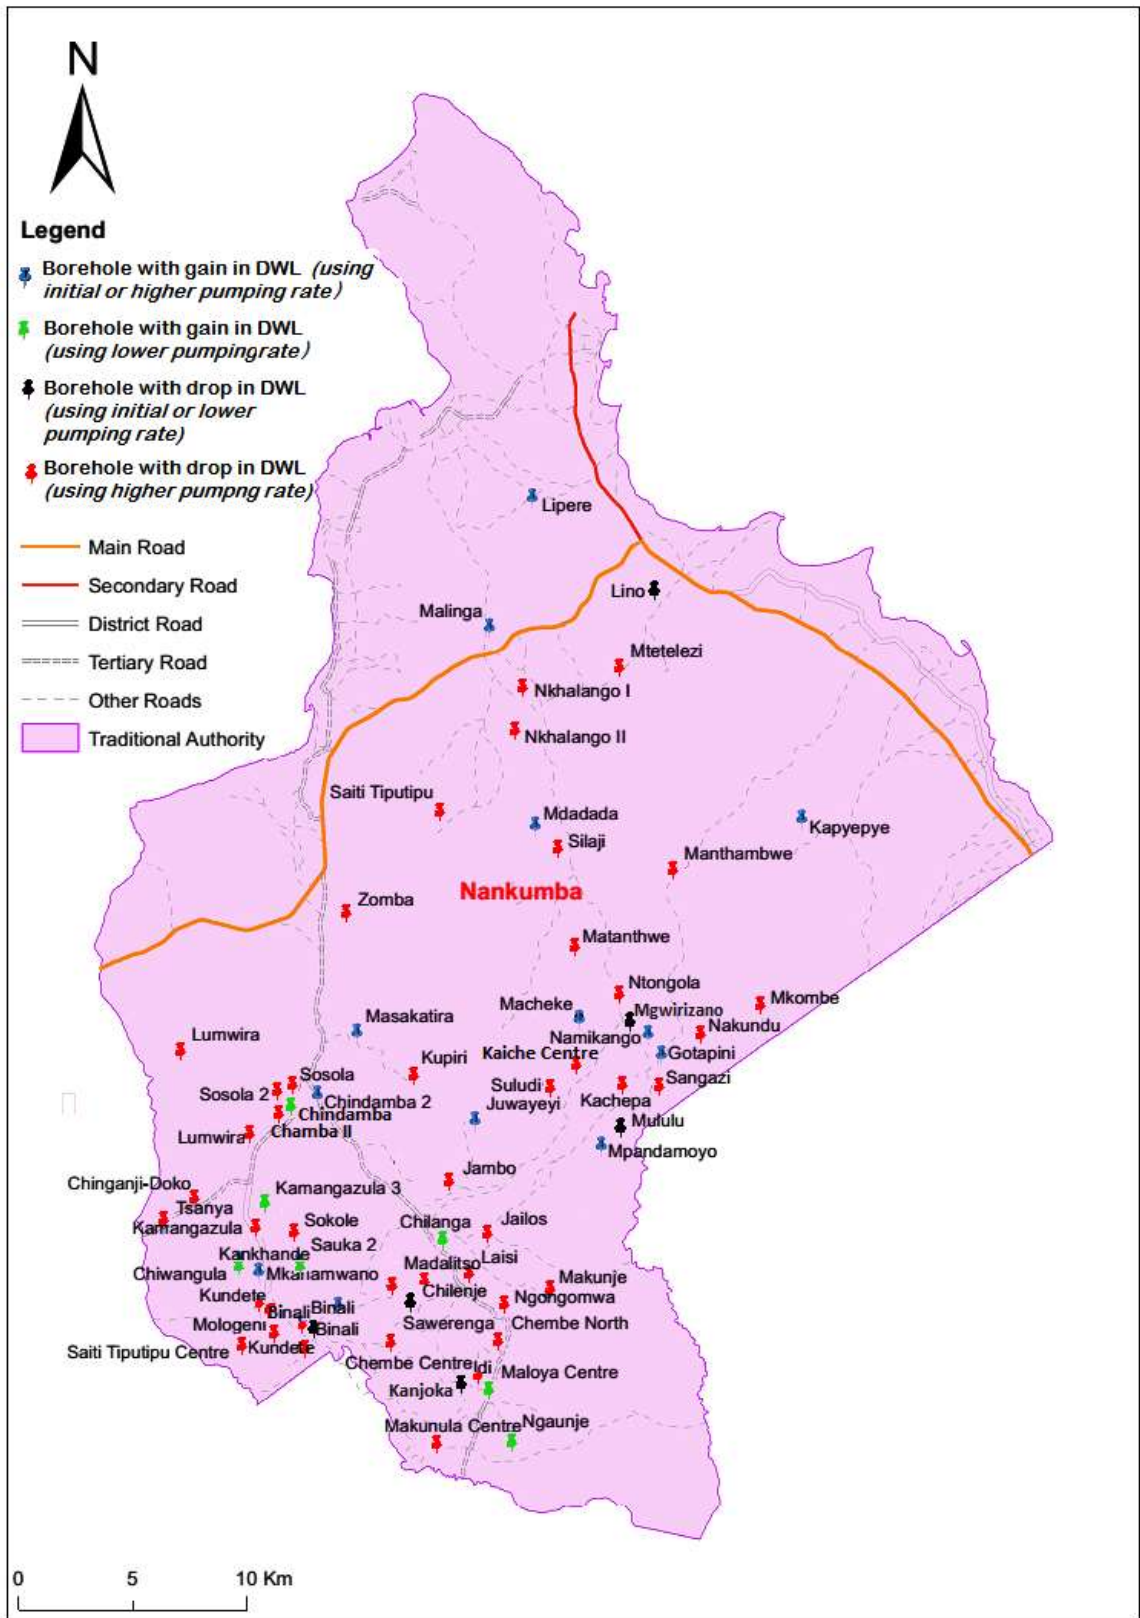
Figure 6: Map of T.A. Nankumba Showing Boreholes with Changes in Dynamic Water Levels

In terms of dynamic water level, it was revealed that in general, 49 (70%) of the boreholes had dropped in dynamic water levels. However, six of these 49 boreholes were exposed to a slightly higher pumping rate than the initial pumping rate during the pumping tests and therefore it would be difficult to conclusively declare them to have dropped in dynamic water level in comparison to the initial dynamic water level. As such, the boreholes that should conclusively be said to have dropped in dynamic water level would be those that were tested at a pumping rate equal to or lower than the initial. In this regard, it was conclusively revealed that 43 (62%) boreholes had dropped in dynamic water level as provided in Figure 6 below, and the drop ranged from 0.27m as the minimum drop to 49.96m as the maximum drop.

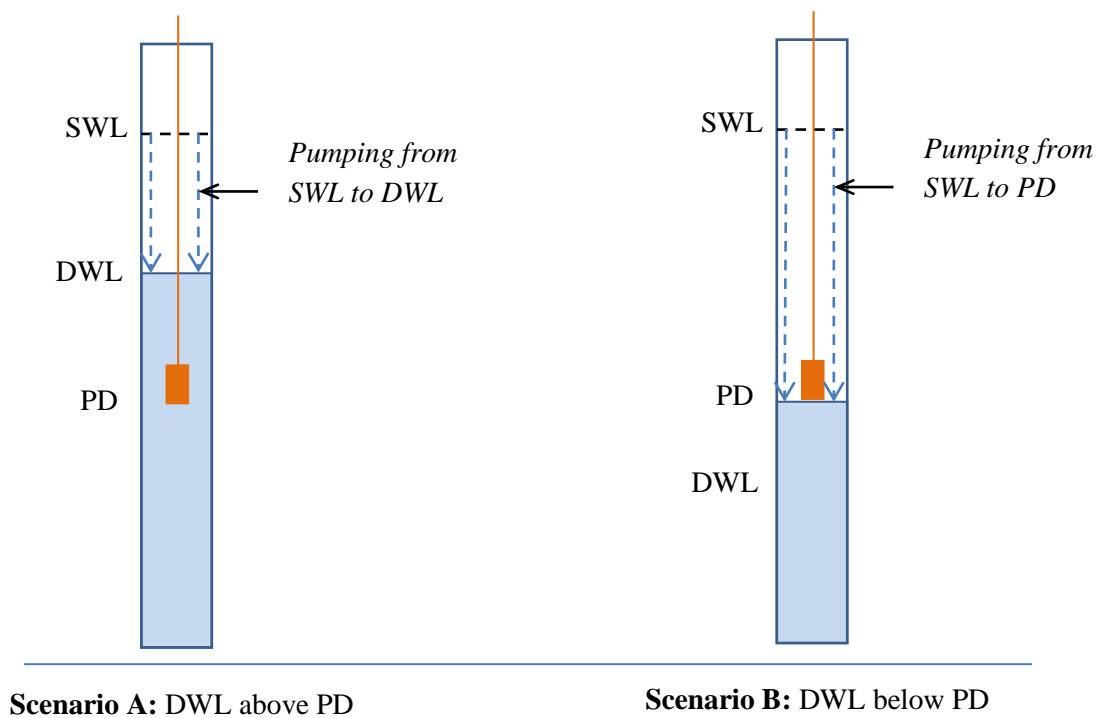
Figure 7: Illustration of Changes in Dynamic Water Level

This dropping in dynamic water level could cause the borehole to easily run out of water while pumping if the drop is way below the pump depth. The water would run out because the pump is now above the dynamic water level such that as the water is being pumped, it would reach the pump depth (PD) before it stabilises at the DWL. As a result users would have to wait for water recovery to start pumping again. Figure 7 below illustrates a borehole that has been pumped to a dynamic water level under different scenarios as discussed above.

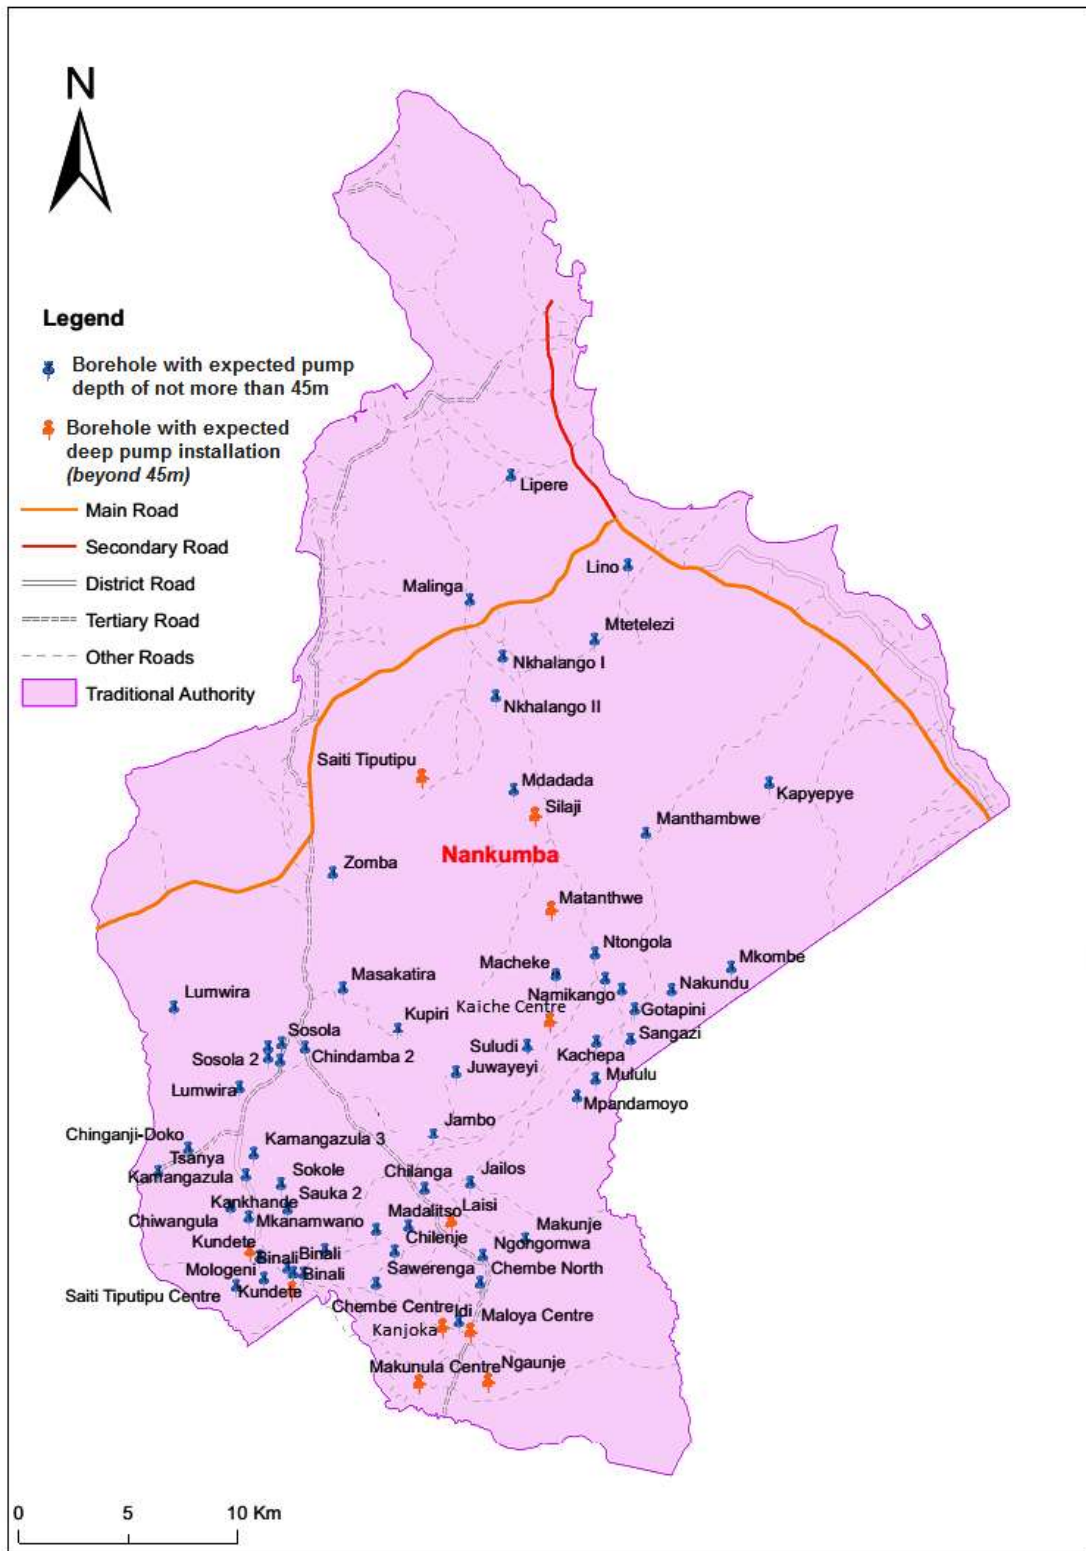
Figure 8: Map of T.A. Nankumba Showing Boreholes with Expected Deep Pump Installations

Looking at the scenario in question above and given other parameters constant, every three metre drop in dynamic water level would mean an additional pump rod being installed in order to compensate for the original pump installation design so as to maintain a consistent flow of water from the boreholes. However, there is also a limit to how deep the pump can go in order to effectively and efficiently pump the water. For the Afridev Hand pump, which is the most commonly adopted and used hand pump in Malawi, including in the WaSNan Project, the maximum depth of installation as per its design is 45 metres (Baumann & Keen, 2007; ‘Resources - RWSN’, n.d.). Any deeper installation, i.e., beyond 45 metres makes the pumping to physically be difficult and the mechanical stresses and wears on the hand pump parts become greater, resulting in frequent breakdowns due to mechanical failures (Lutz et al., 2014). And this could be the scenario for 11 boreholes, shown in Figure 8 below, whose

dynamic water levels dictate that they should be installed to a depth beyond the 45 metre depth, the worst case being a dynamic water level of 62.09 metres followed by 56.76 metres.

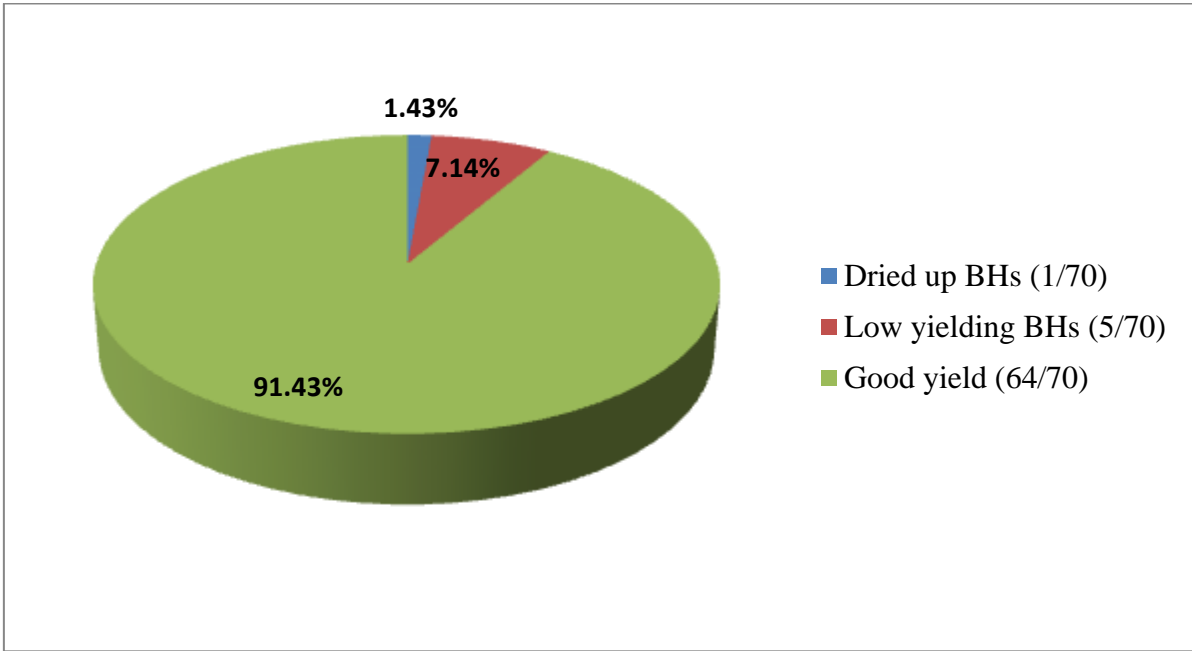
Figure 9: Current Yielding Status of Boreholes

In terms of yield, it was revealed that six (6) boreholes (9%) namely Matanthwe, Chembe North, Laisi, Silaji, Manthambwe and Kaiche Centre, had problems to do with yield. Among the six boreholes, one (1) borehole namely Chembe North had completely dried up despite having a very good yield of 1.0 litre per second in its initial status. The other five (5) boreholes had yielded poorly, below 0.2l/s which was the WaSNan Project's recommended minimum yield. The yields ranged from 0.08l/s to 0.19l/s. As can be observed from Table 1 below, these six boreholes were also falling in the categories of boreholes that dropped in static water level and dynamic water level, meaning that where there was a failure in yield, there were also problems with both static water levels as well as dynamic water levels. The remaining 64 (91%) boreholes had yields that were deemed acceptable on basis of the project's recommended minimum yield of 0.2l/s and the yields ranged from 0.2l/s to 1.25l/s. Figure 9 below gives a summary of the yielding status of all the 70 boreholes while compares the initial and current yield statuses of the six problematic boreholes.

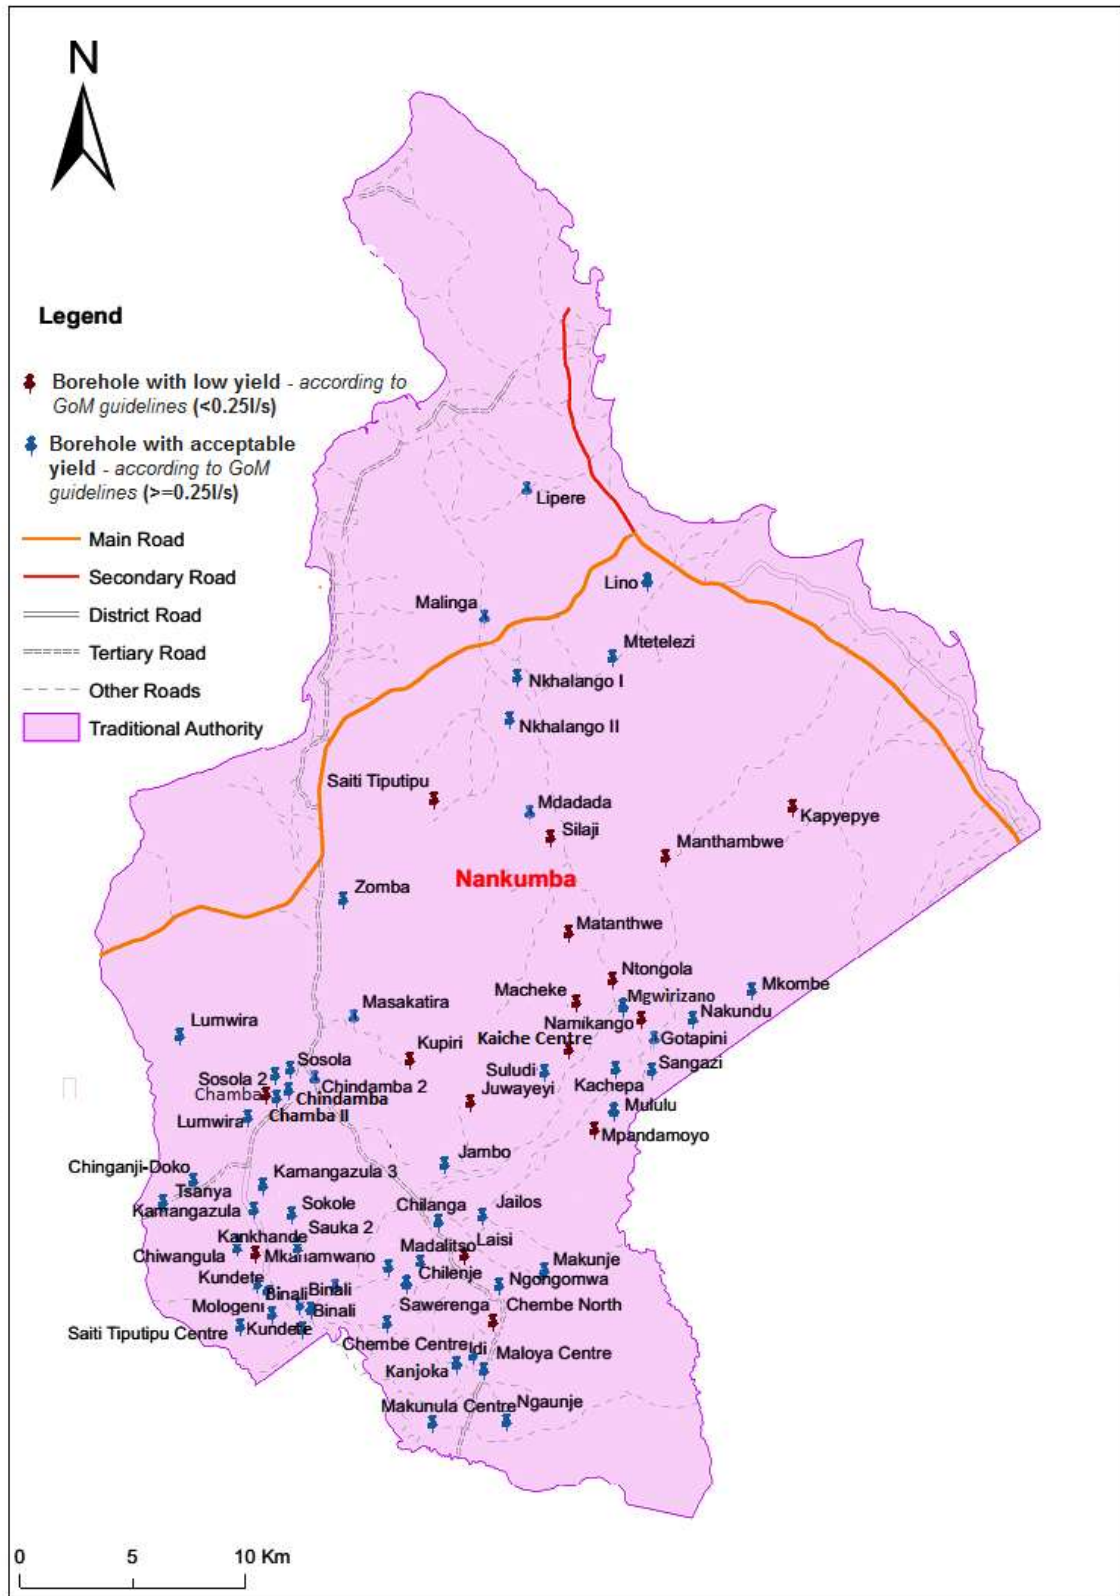
Figure 10: Map of T.A. Nankumba Showing Boreholes with Acceptable and Unacceptable Yields (Using GoM Guidelines)

Although the WaSNan Project set 0.2l/s as the recommended minimum yield, the Government of Malawi recognises 0.25l/s as the minimum recommended yield for boreholes in Malawi. Therefore taking into account this government’s recommended minimum yield, the number of boreholes with unacceptable yields from the current status would then be 16, as shown in Figure 10 below. The yields of these 16 low yielding boreholes then range from 0.08l/s to 0.23l/s. On the other hand, if the project had adopted the 0.25l/s as the minimum yield during construction, 17 boreholes from the initial status would have been deemed unsuccessful.

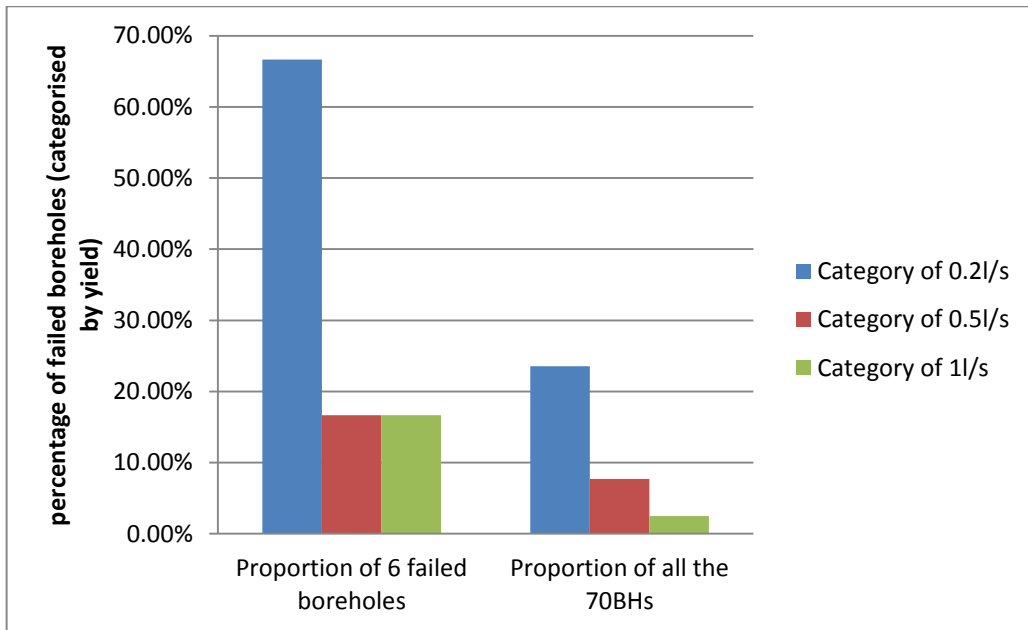
Figure 11: Relationship of the Six (6) Failed Boreholes to Initial Yield

As provided in Figure 11 below, out of the 6 boreholes that failed in terms of yield, 4 boreholes (Matanthe, Laisi, Silaji and Kaiche Centre) had the lowest initial recorded yield of 0.2l/s, representing 66.7% of the failed boreholes. One (1) borehole of the failed boreholes (Manthambwe) had 0.5l/s and the last 1 borehole (Chembe North) had 1.0l/s. In terms of categorical proportionality, 23.5% (4/17) of the boreholes that had initial yield of 0.2l/s failed, while for those with 0.5l/s it was only 7.7% (1/13) that failed and only 2.5 % (1/40) of the boreholes which had initial yield of 1.0l/s failed. It was also revealed that the borehole that completely dried up was the one with the highest recorded initial yield of 1.0l/s as at the time of construction.

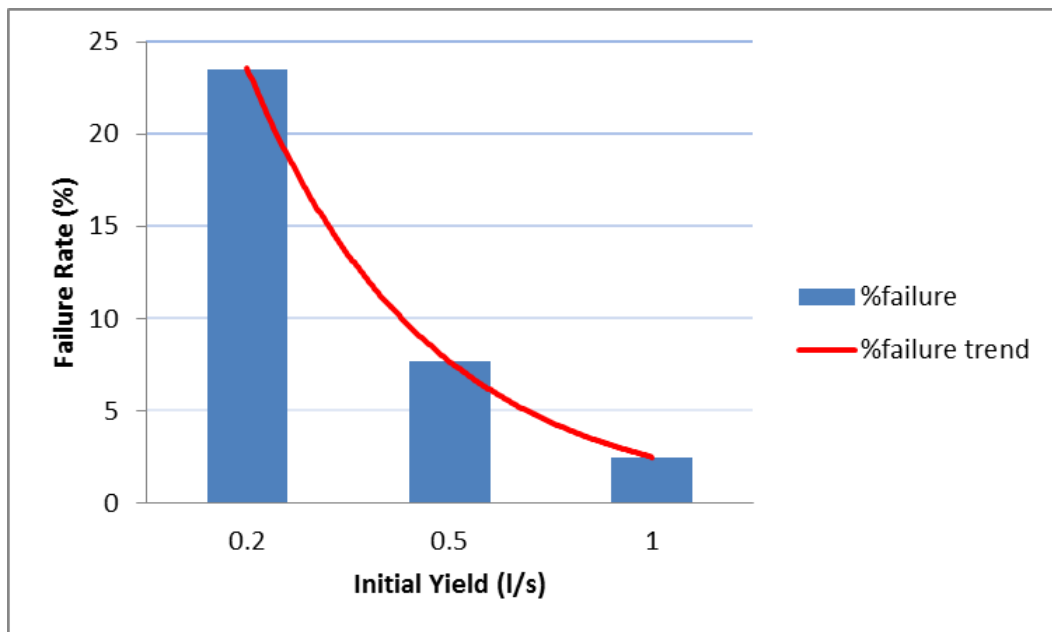
Figure 12: A Trend of Failure Rates Proportional to Initial Yield Category

As it can be observed from the findings, the boreholes with the lowest initial yield at construction are the ones that failed most proportional to their yield category. Further to this, the proportionality failure rate decreases with an increase in yield as seen from the trend as provided in Figure 12 below. This finding agrees with what Harvey (2004) deduced that boreholes that have low yields at the time of drilling are the ones that usually fail. In the findings of his study in Ghana, he observed that a higher percentage of the boreholes that failed had initial yields of less than 13litres per minute, equivalent to 0.22 litres per second which is slightly above the threshold yield of 0.2 litres per second.

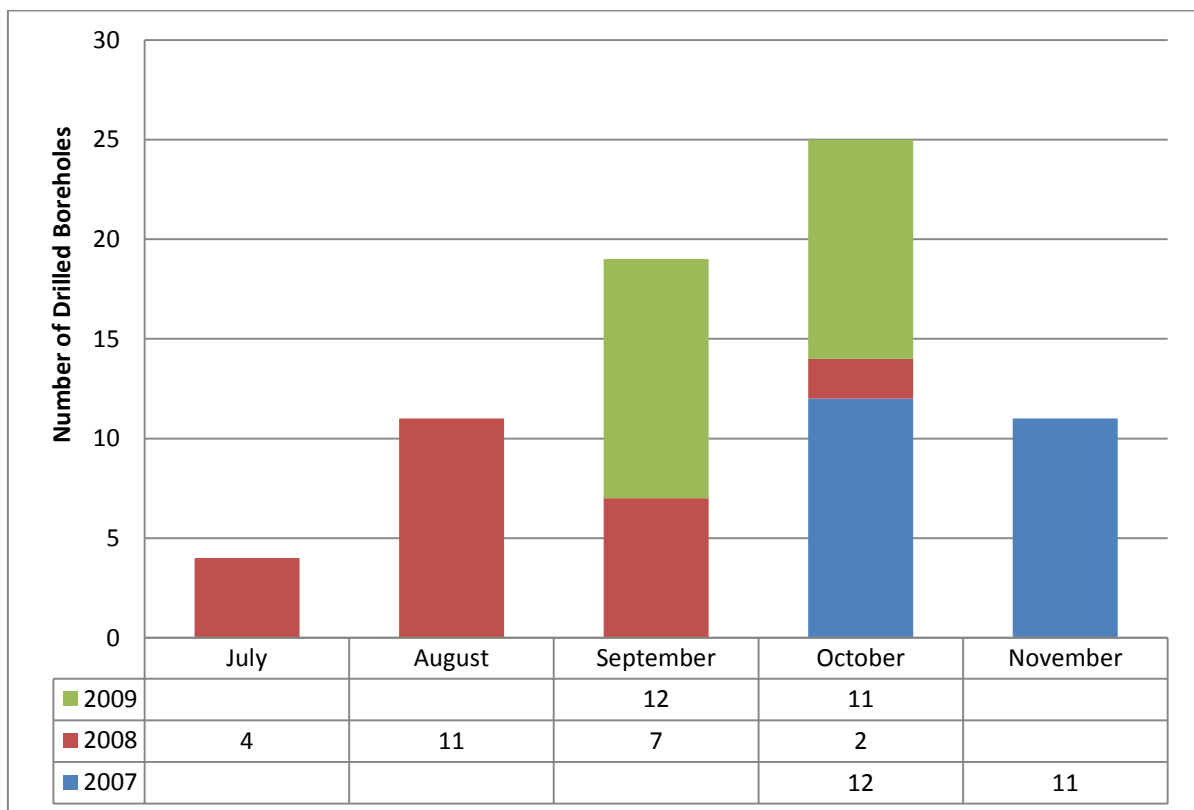
Figure 13: Monthly Distribution of the Drilled Boreholes

In terms of the season in which drilling for these boreholes under study took place, it was revealed that all the boreholes were drilled and pump tested in the dry season. For boreholes

constructed in 2007, drilling and pumping tests took place between the months October and November, whereas for those constructed in 2008, drilling and pumping tests took place between the months of July and September. Finally, drilling and pumping tests took place between the months of August and September for the boreholes constructed in 2009. In general, the drilling and pumping tests of these boreholes were done between the months of July and November and these months fall within the dry season in Malawi, which is the best time for drilling boreholes. Figure 13 below is a summary of how the boreholes were distributed in terms of drilling period as discussed above.
